A Good Intention With A Bad Result!

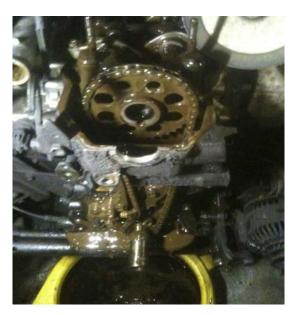
From 1975 to 1982, Toyota produced the 20R & 22R four-cylinder engines that utilized a dual timing chain system. It proved to be very dependable and included steel timing chain guides. Then in 1983, Toyota decided to install the single row chain with plastic guides on all of their 22R engines. The single row timing chain is prone to stretching beyond the tensioner's limits, resulting in a loose chain. As the chain stretches, several things can occur. You experience improper camshaft timing, the plastic guides eventually break, the timing chain can either wear a hole in the timing cover or break entirely sending the pistons and valves to meet their fate. Not a pretty picture. LCE does supply a very heavy-duty single row chain with metal guides to give a little more life expectancy. Below you will see pictures of the 22R/RE motor that had a guide fail, resulting in coolant mixing with the oil.

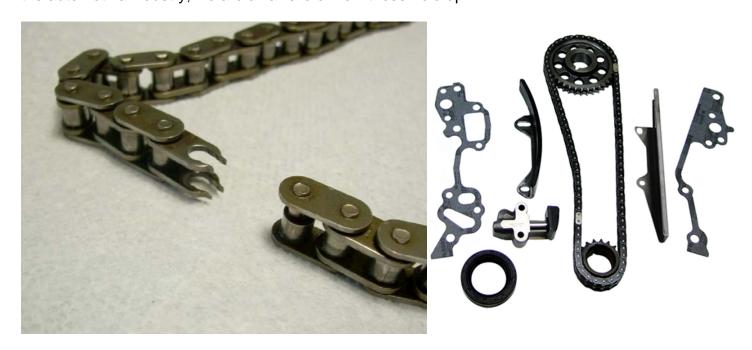
From 1985 to 1995, Toyota was still producing the single row timing chain for the 22R series engine, but made the deck height of the block and cylinder head shorter. This changed the centerline distance between the crankshaft and camshaft resulting in a shorter chain. Toyota recommends that you replace the single row chain every 80k miles depending on how hard the vehicle has been driven. When replacing the chain make sure that you do not cheap out or settle for an "off the shelf" or "local parts store" kit. It is not uncommon to see a lot of Chinese product in the automotive industry, we are all aware of how those hold up!

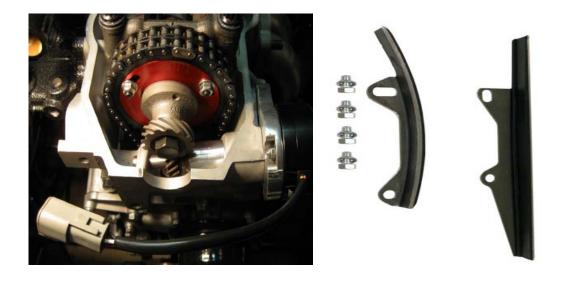
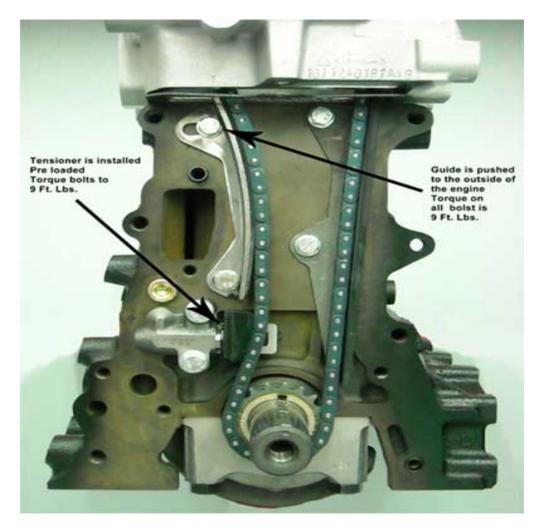
- 1) Toyota recommends changing the Chain Kit every 80k miles on a stock engine light duty application or when excessive chain slap or rattle is noticed.
- 2) Change the Chain Kit every 80k and upgrade to a Single Chain Late Steel Guide Kit. Warning: This will not prevent the chain from stretching. Prolonged engine usage will result in the chain breaking and that is much worse than a water leak. Suggested for use in light duty operation only.
- 3) The LC Engineering Exclusive! Timing Chain Conversion Kit was designed in 1985 when we experienced these issues. This kit provides the customer with all the necessary components required to install a double chain with steel guides on your 1985-95 22R/RE engine. This Timing Chain Conversion Kit will outlast the vehicle and handle all the high performance demands that you require. Problem solved!

As the evolution of our performance engines took place, LC Engineering was experiencing problems with the single row timing chain failure. So, in 1985 when the new generation of the 22 was released, we anticipated this to be a weak decision and built an updated kit. What a positive impact this made on the quality and performance of our engine packages. This kit is also available for those who want to convert their 1983 and 84' 22R series engine over to the dual row chain.
